# Scientific Analysis of Inkjet Prints at the National Gallery of Art

A Survey of Conservation Science  
Analytical Techniques

Sarah Fong

3 April 2025

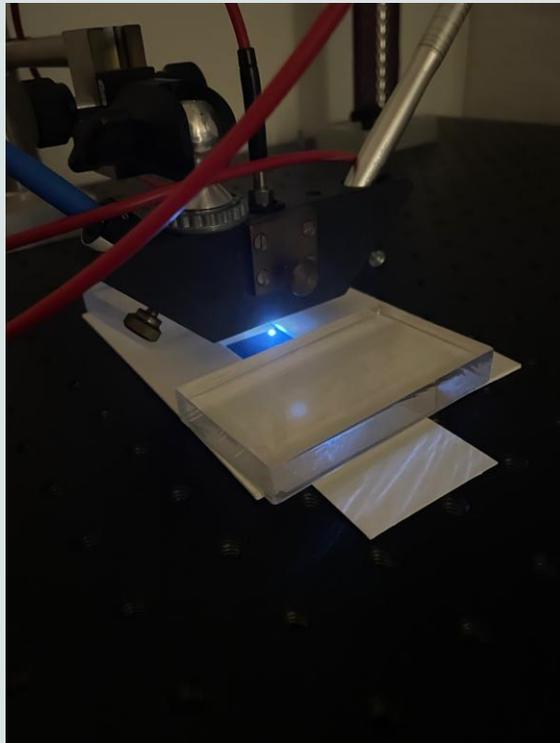
Microfade Tester  
(MFT)

*Simulated light  
exposure*

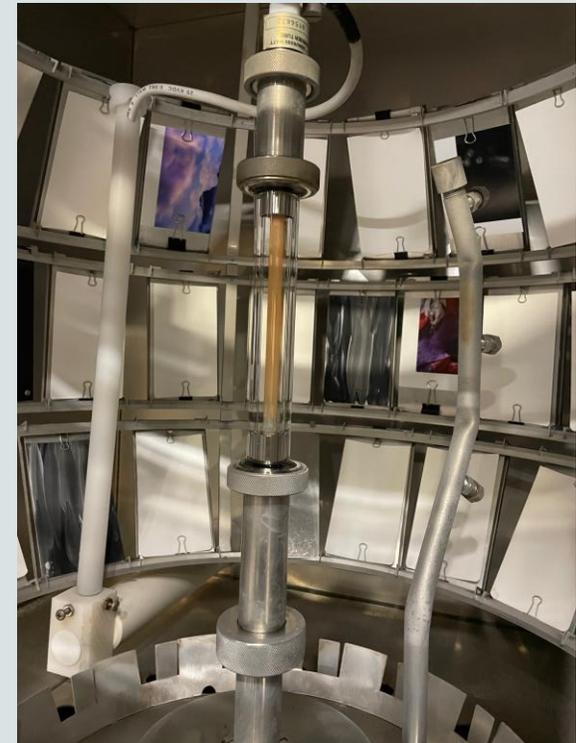
Weatherometer with  
Colorimetry

*Artificial aging with  
light and temperature*

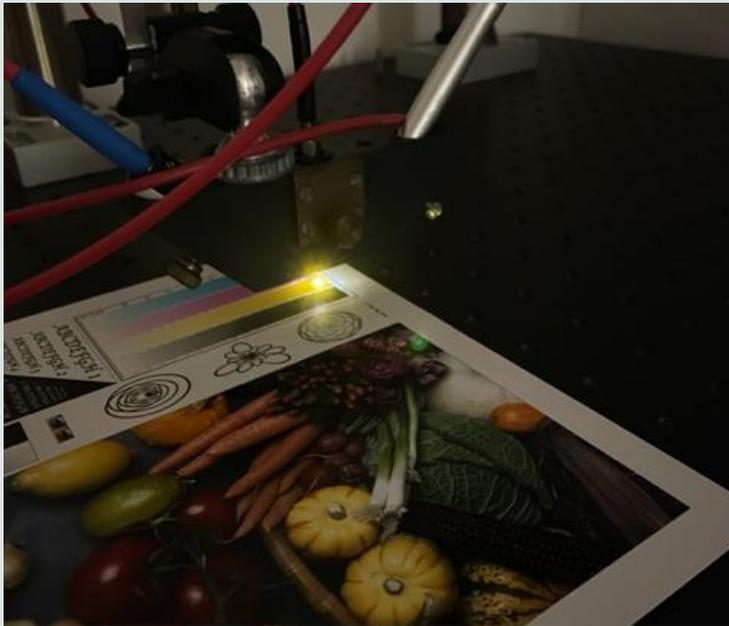
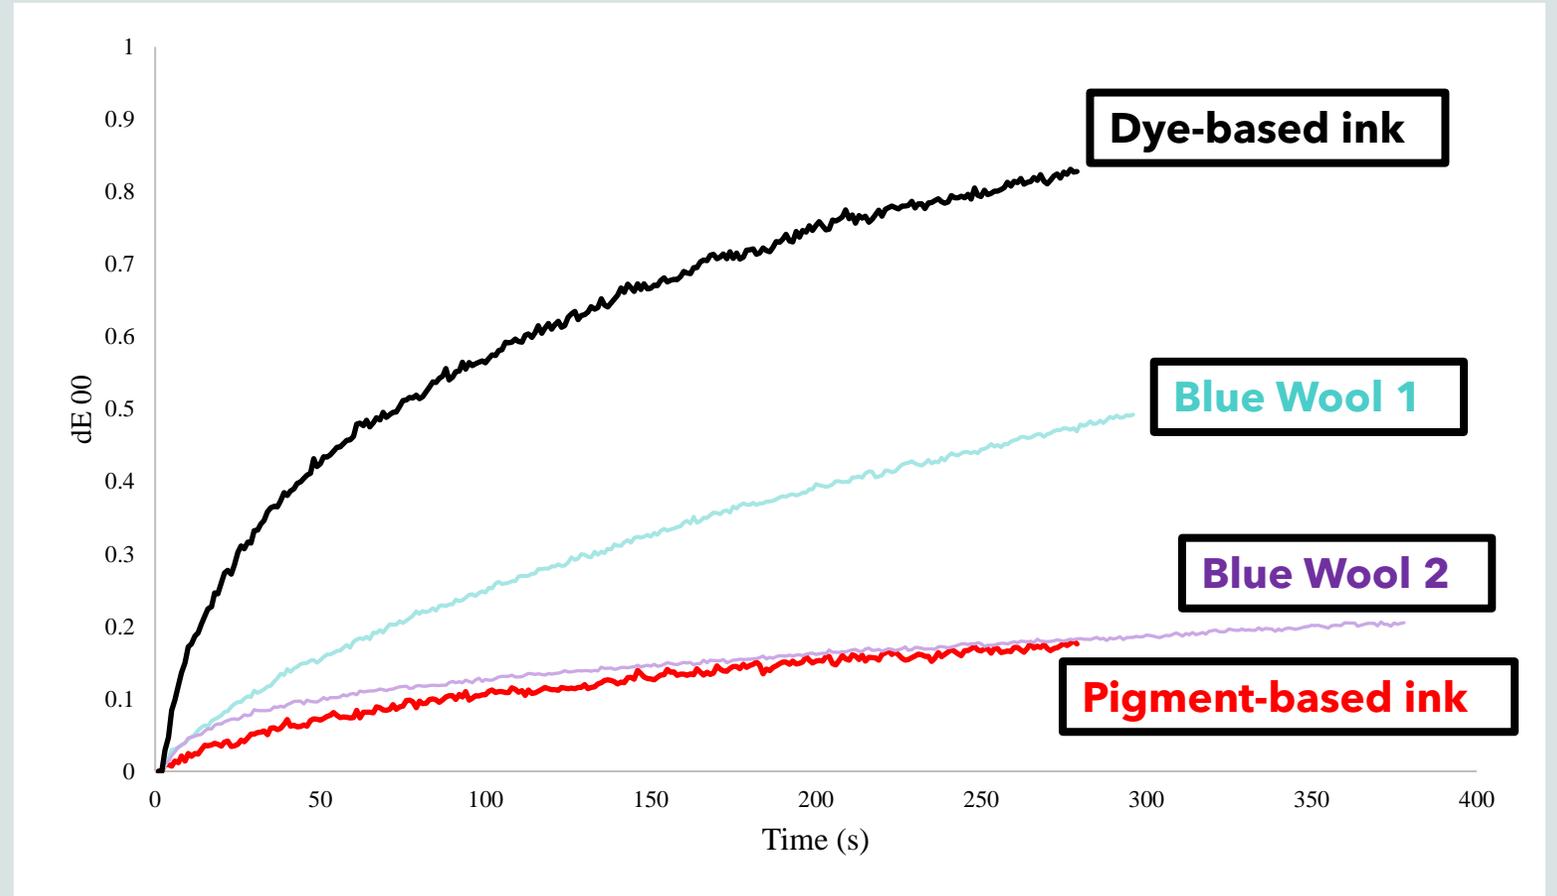
# MFT reveals dye-based inks in study set were light fugitive

Microfade Testing graph reveals two colored inks are above blue wool standard 2.

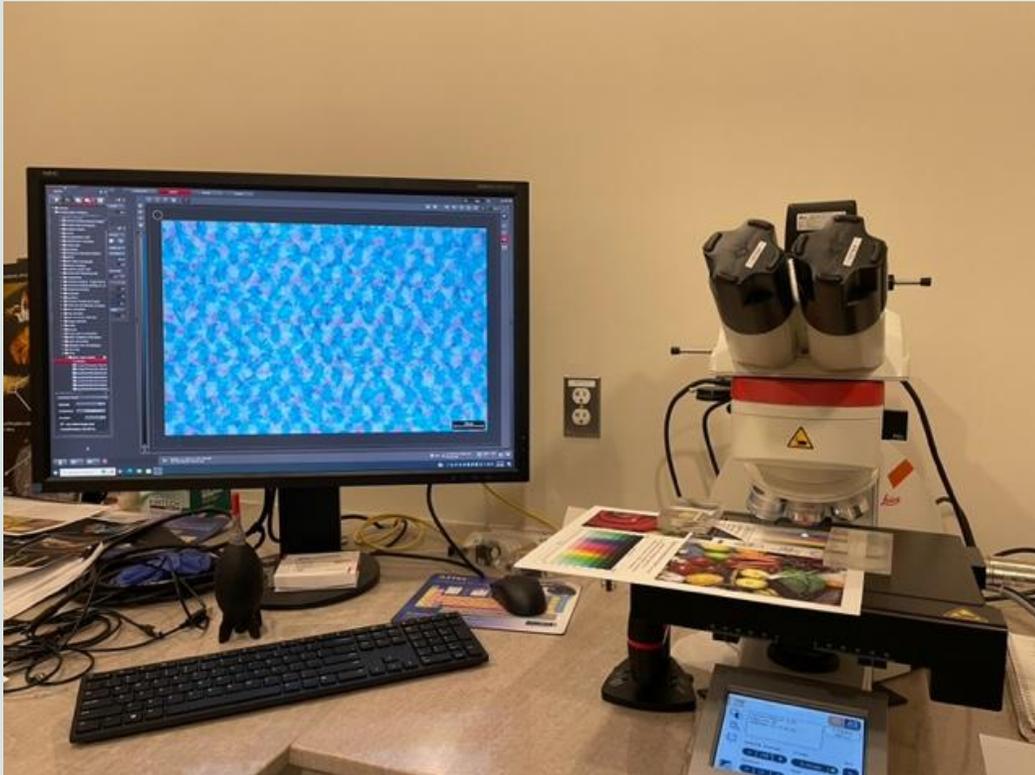
Microscopy

*Magnification*

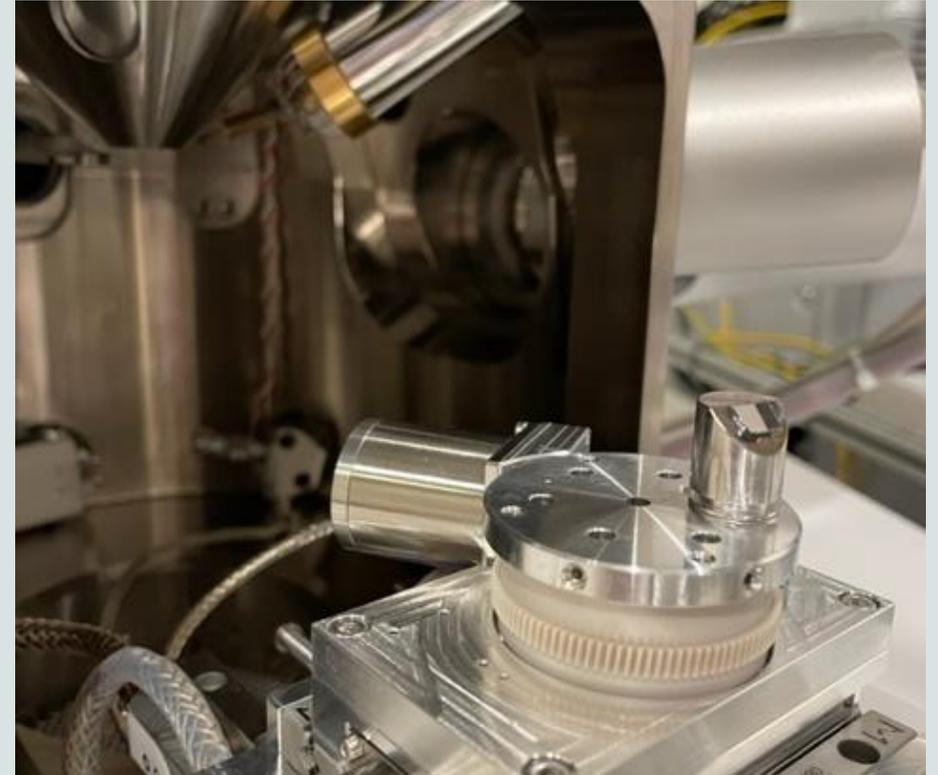
SEM/EDX

*Sampling; electron beam generates an image*

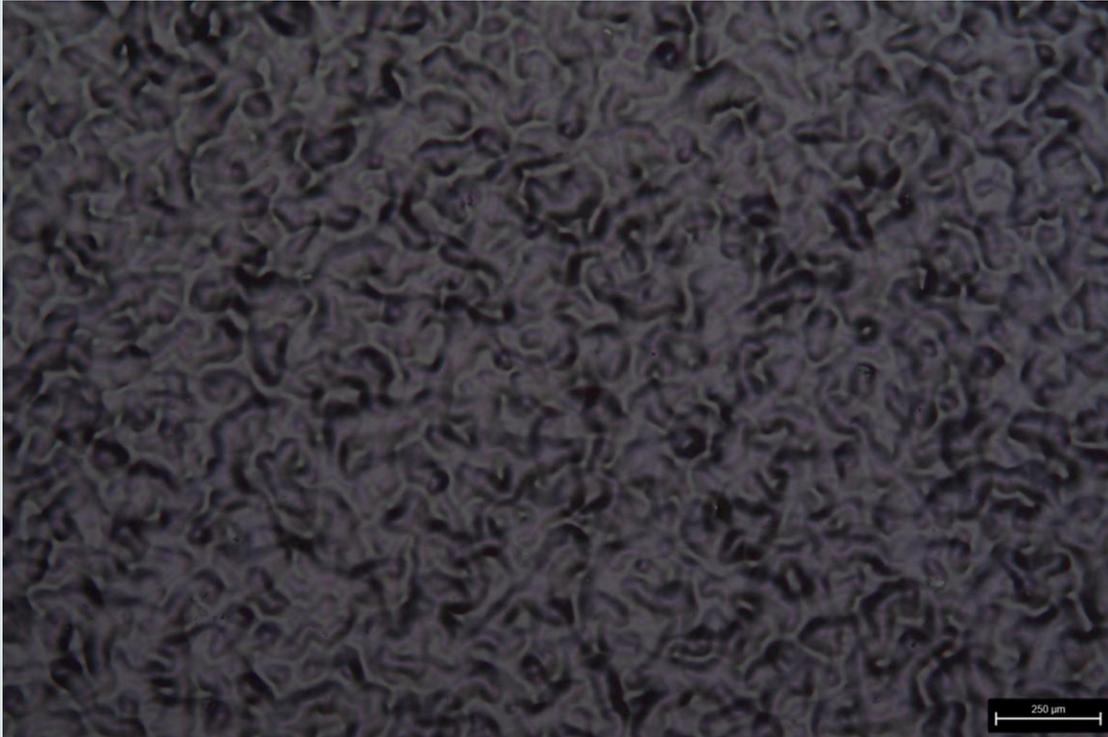
# Microscopy shows “black” in studied inkjets is made up of multiple colors

Chromogenic print of black dye. Scalebar represents 250  $\mu\text{m}$ .

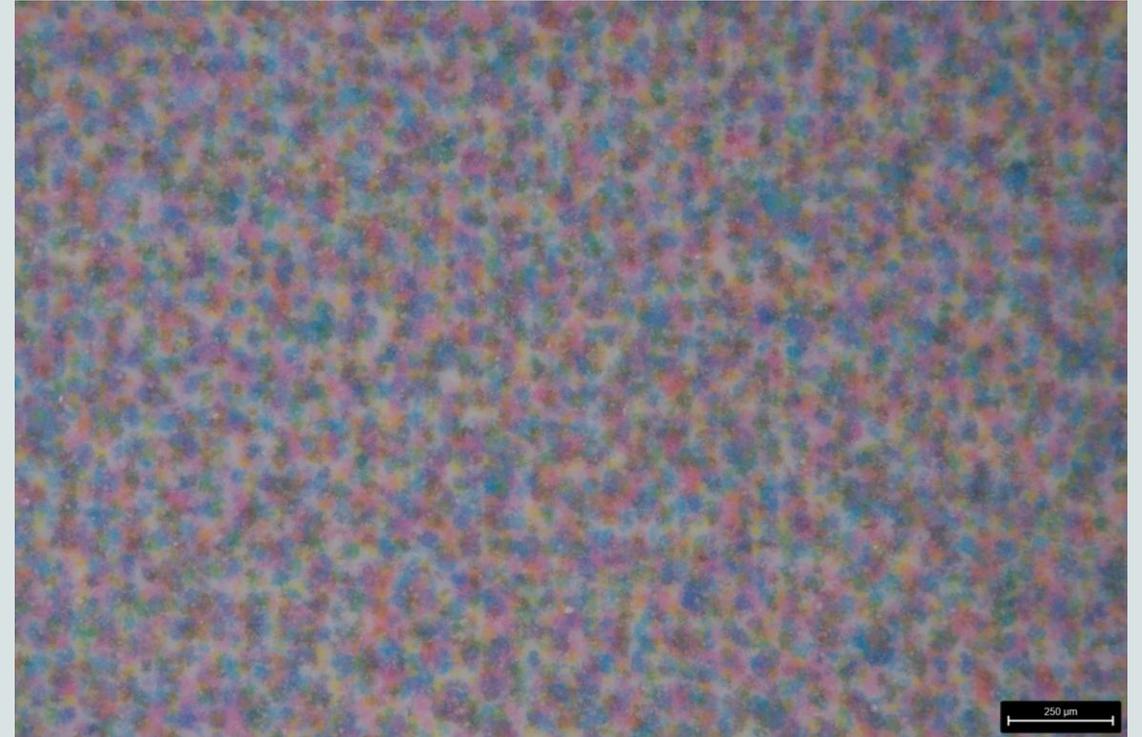
Inkjet print of black dye. Scalebar represents 250  $\mu\text{m}$ .

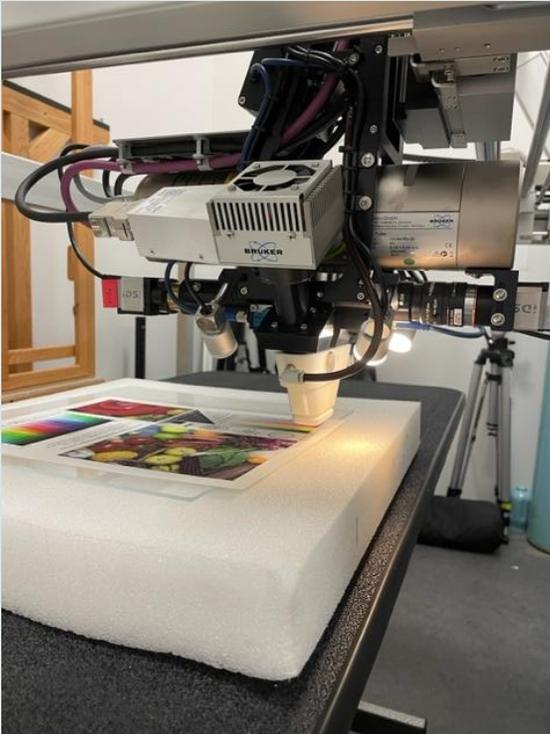
XRF

*Detects specific x-ray signals*

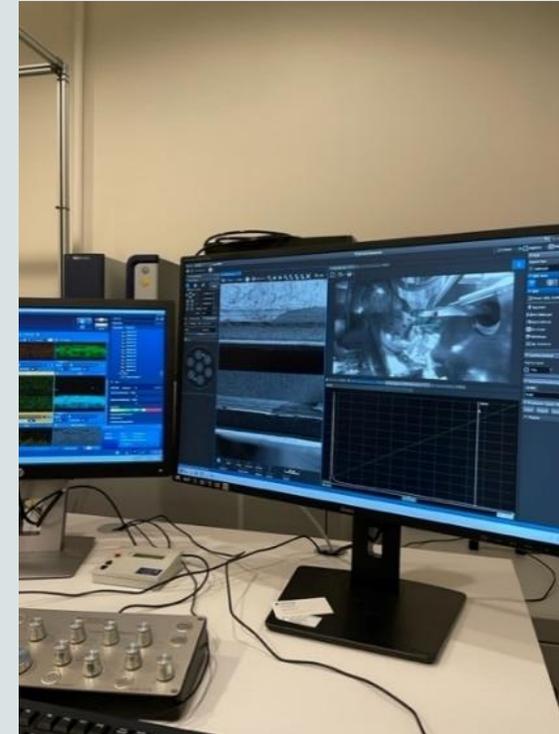
SEM/EDX

*Sampling; generates elemental maps*

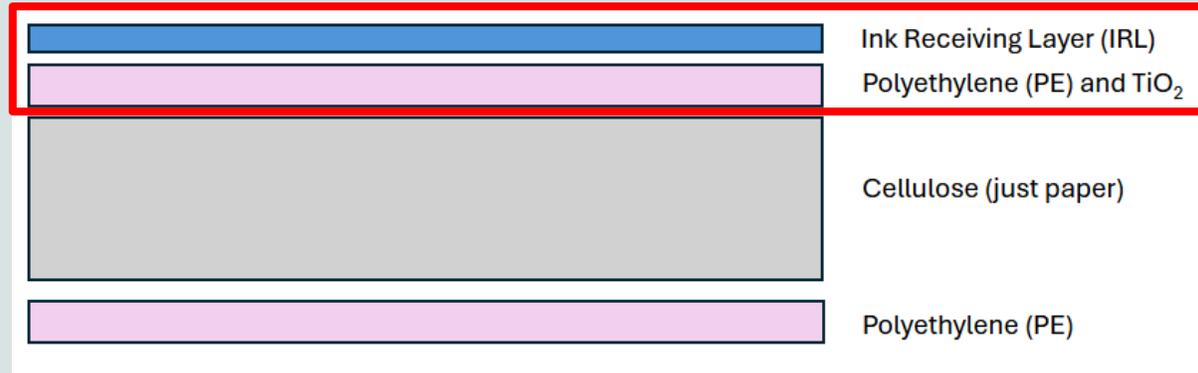
# EDX helped identify RC papers through layer-specific information

**Layers of a resin-coated (RC) paper**

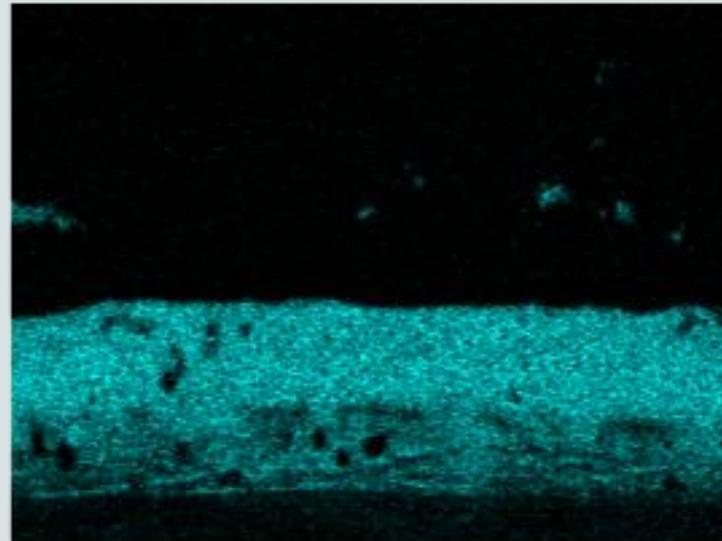
Si K $\alpha$ 1

**Ink Receiving Layer containing silica (SiO<sub>2</sub>)**

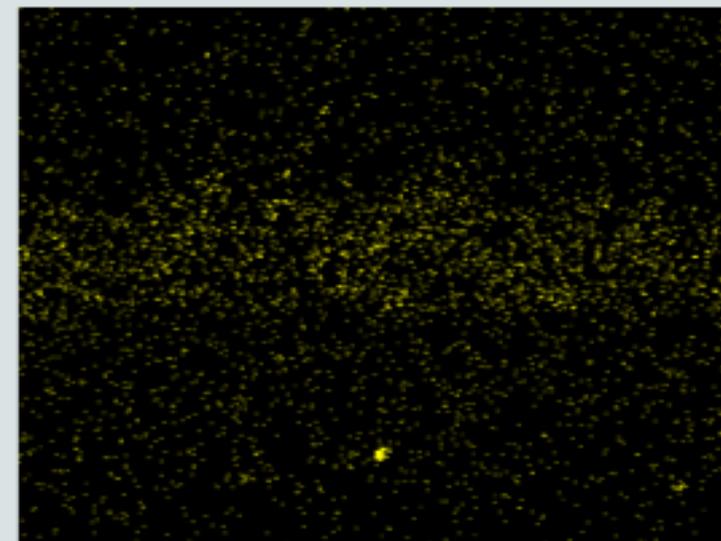
Ti K $\alpha$ 1

**Polyethylene layer with TiO<sub>2</sub>**

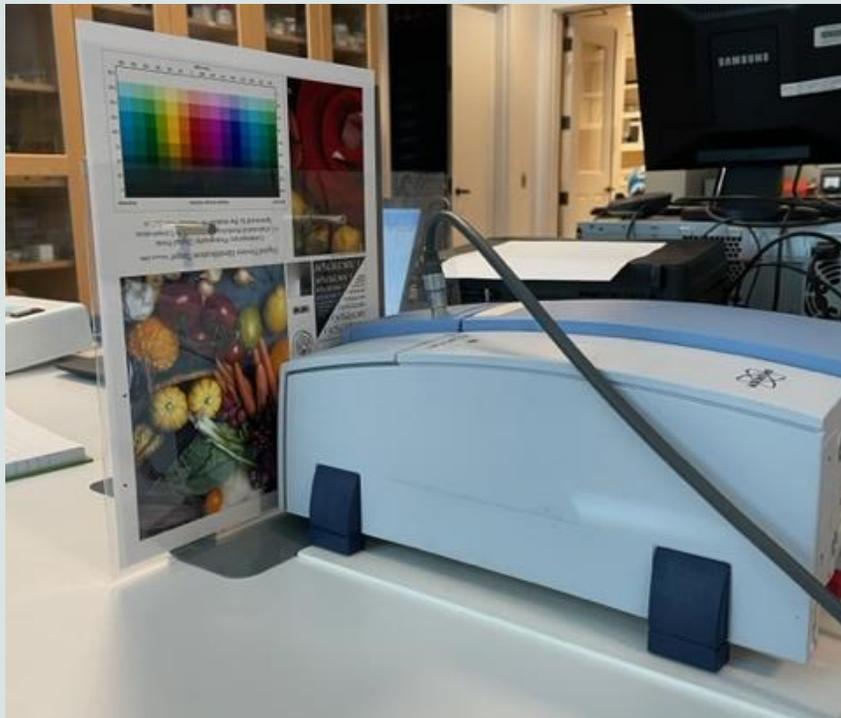
ER-FTIR

*Non-contact method*

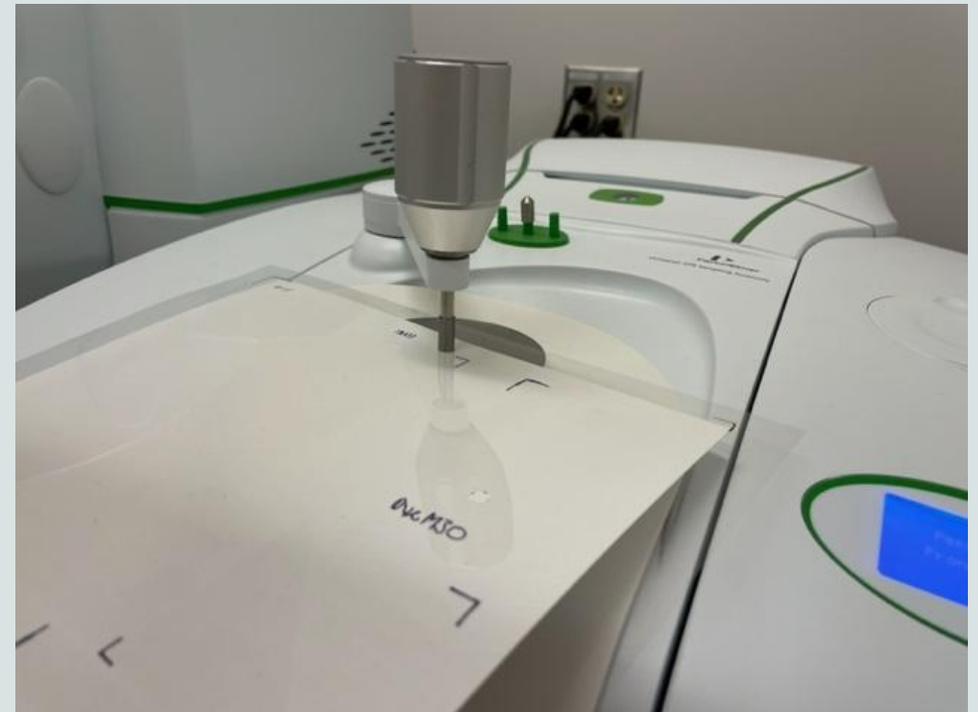
ATR-FTIR

*Contact; surface specific*

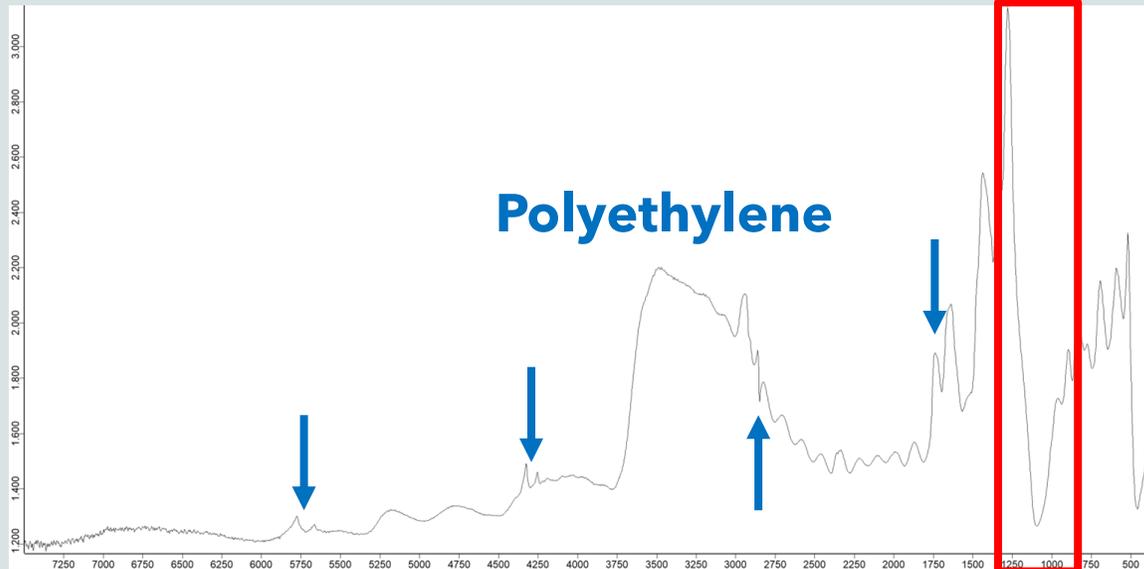
ER Spectrum

Sample is printed on an RC paper.

Polyethylene and silica have been detected in this spectrum.

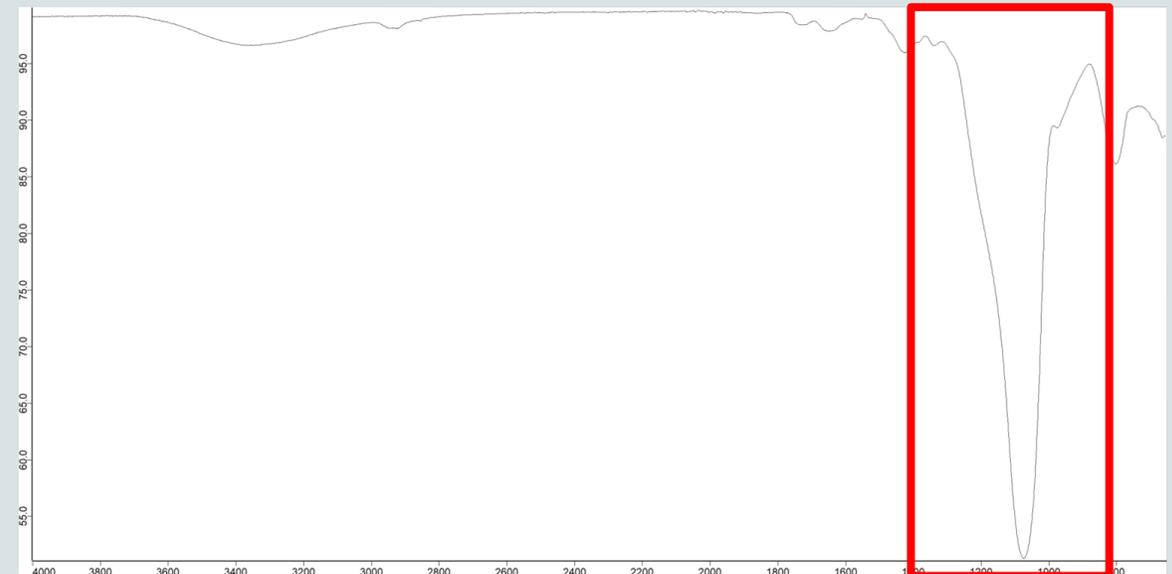
ATR Spectrum

Silica is present on the surface of the sample.

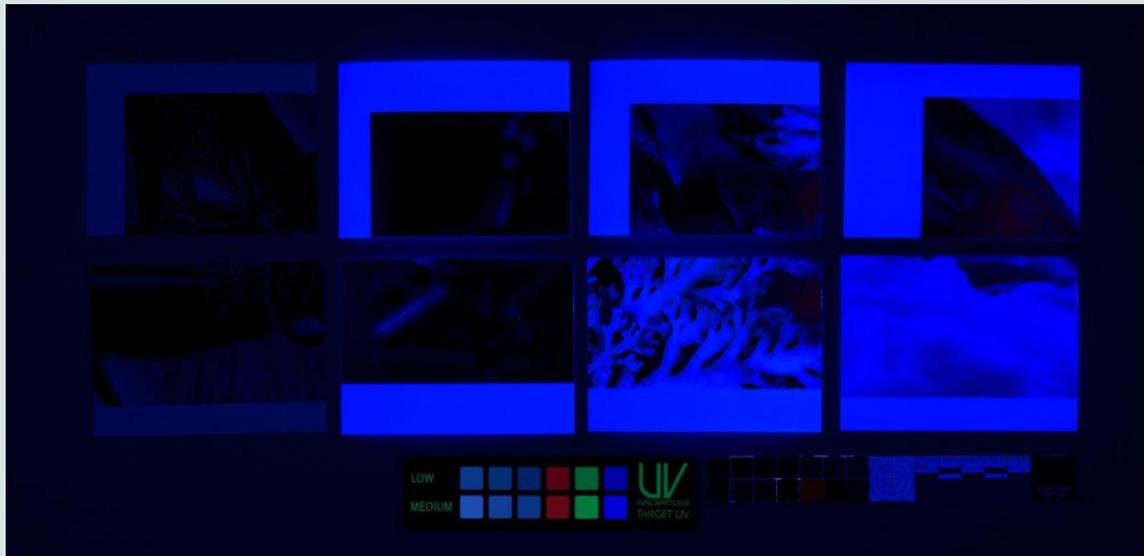
**Unaged**

Weatherometer (destructive) light-induced aging reveals degradation of optical brightening agents. Can we tie these results to MFT (non-destructive)?

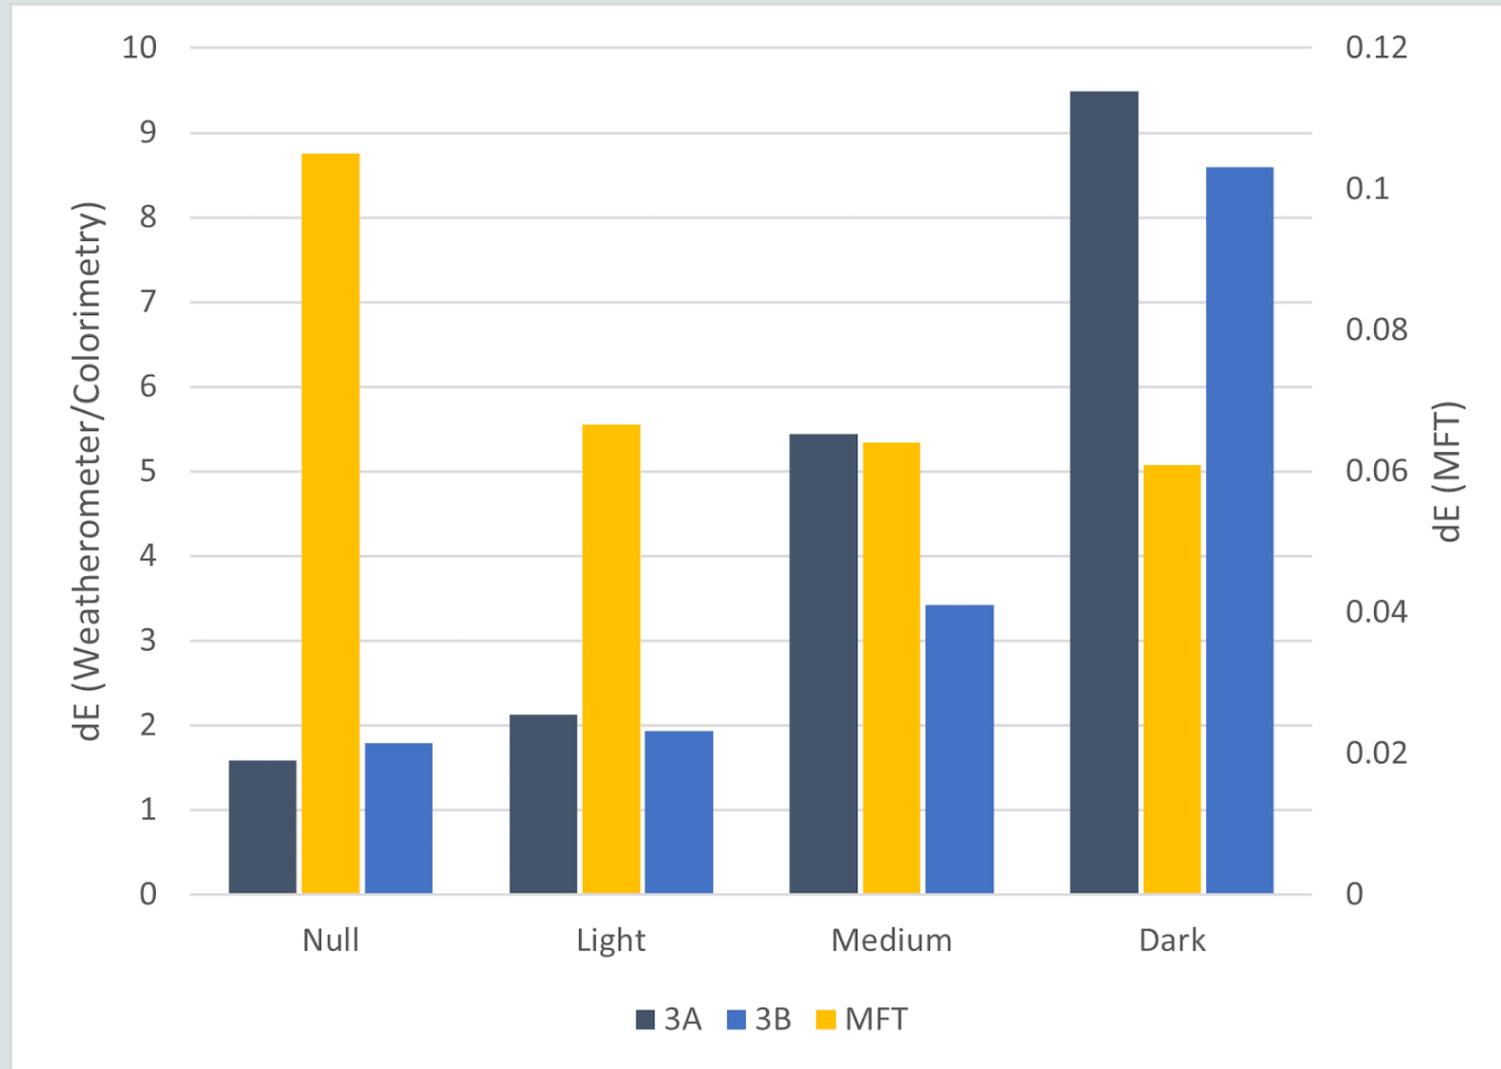
# Weatherometer shows bias in MFT measurements

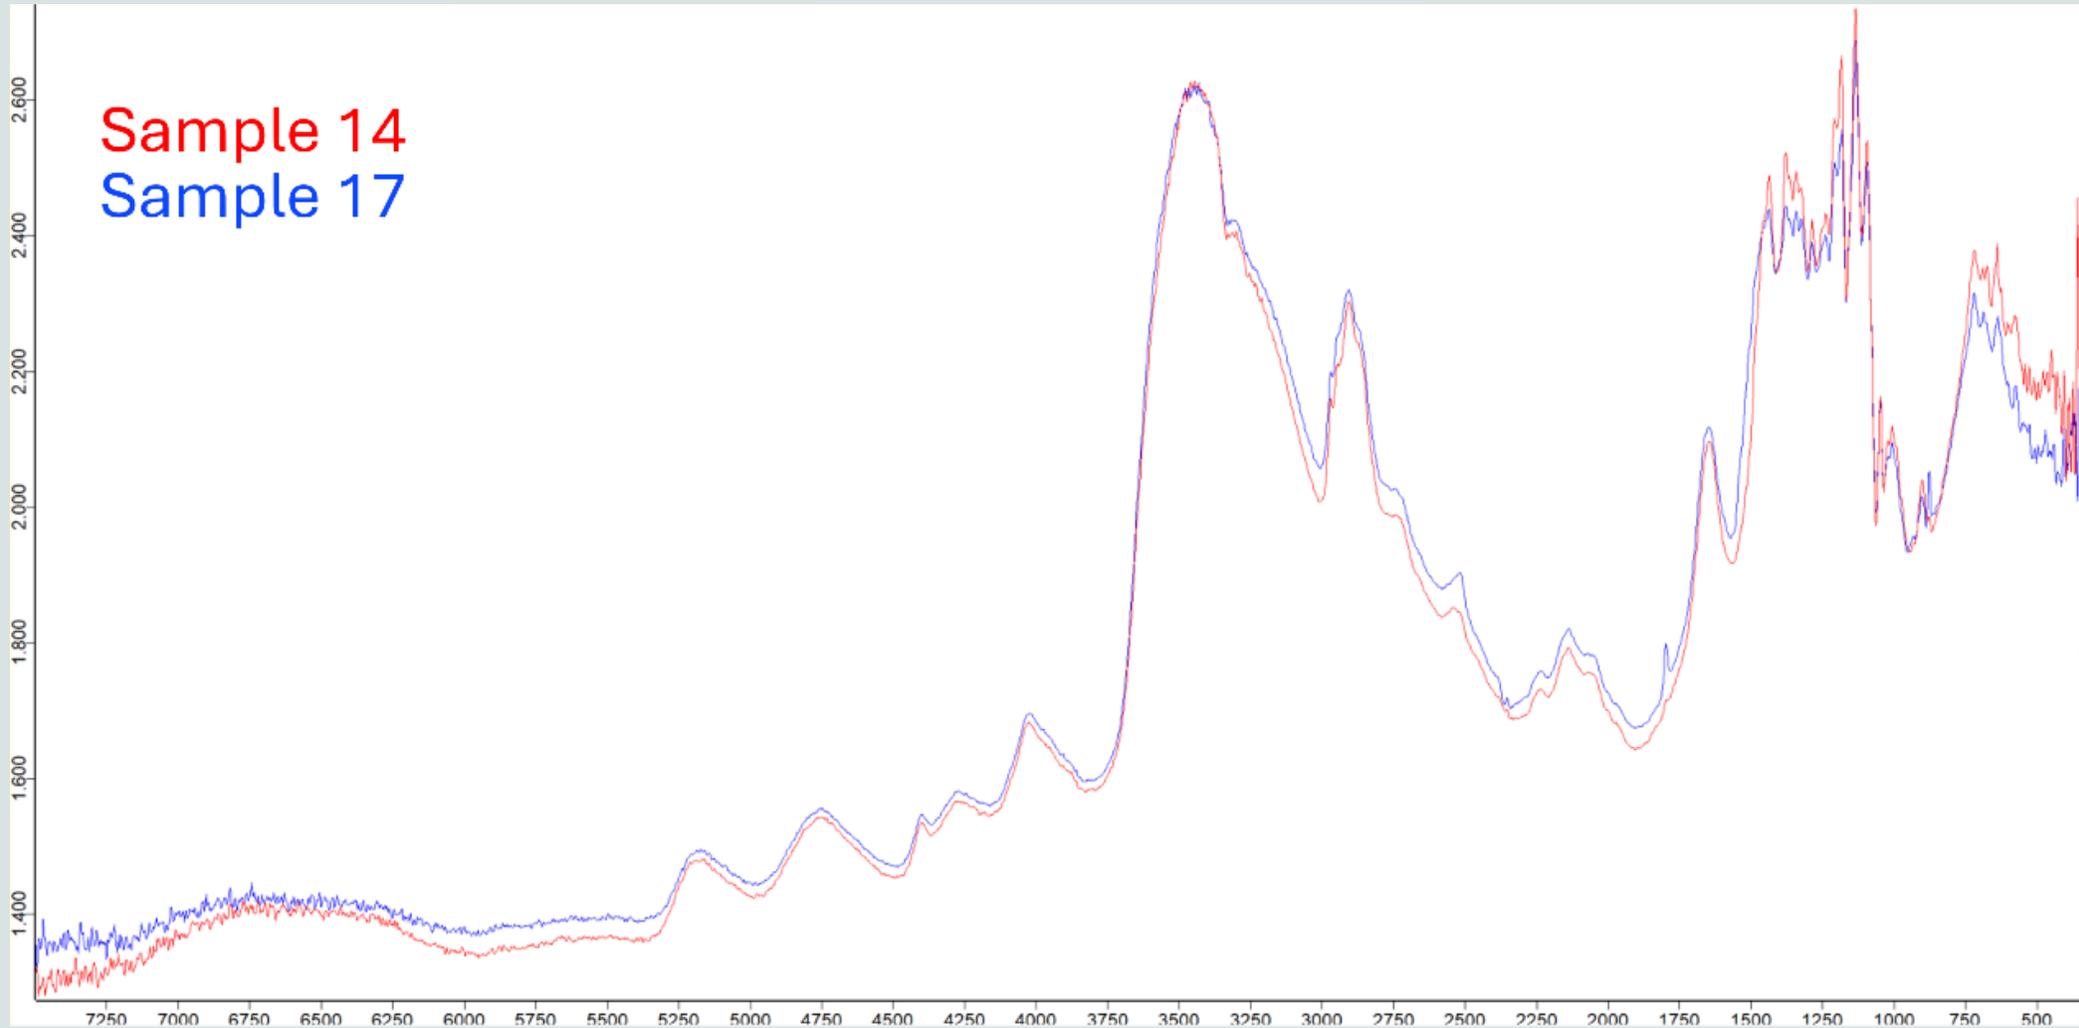
# Not all coatings are detectable with FTIR analysis

ER-FTIR spectra reveal coatings are undetectable.

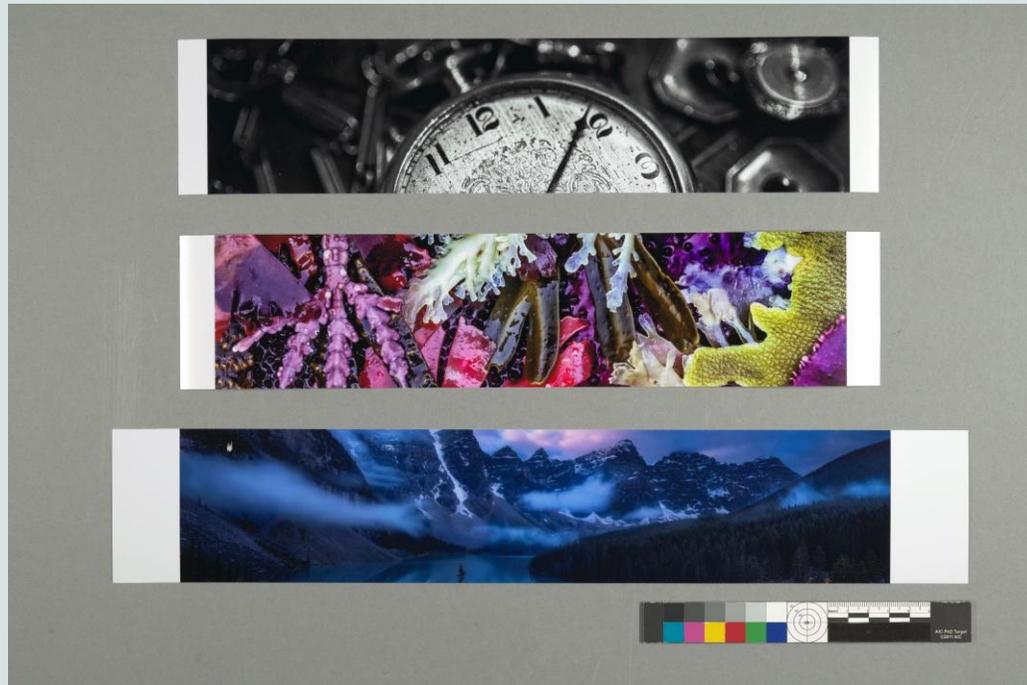
BEFORE AGING

# Artificial aging reveals some storage conditions can be destructive
